**HOH RIVER TRUST PROPERTIES**  
***CONSERVATION EASEMENT AND LAND MANAGEMENT PLAN***  
***MONITORING REPORT***

*(SPRUCE CREEK UNIT, OCTOBER 29, 2010)*

**MONITORING REPORT**  
**FOR**  
**FALL 2010**

**DATE OF MONITORING VISIT:** October 29, 2010  
**DATE OF MONITORING REPORT:** November 5, 2010

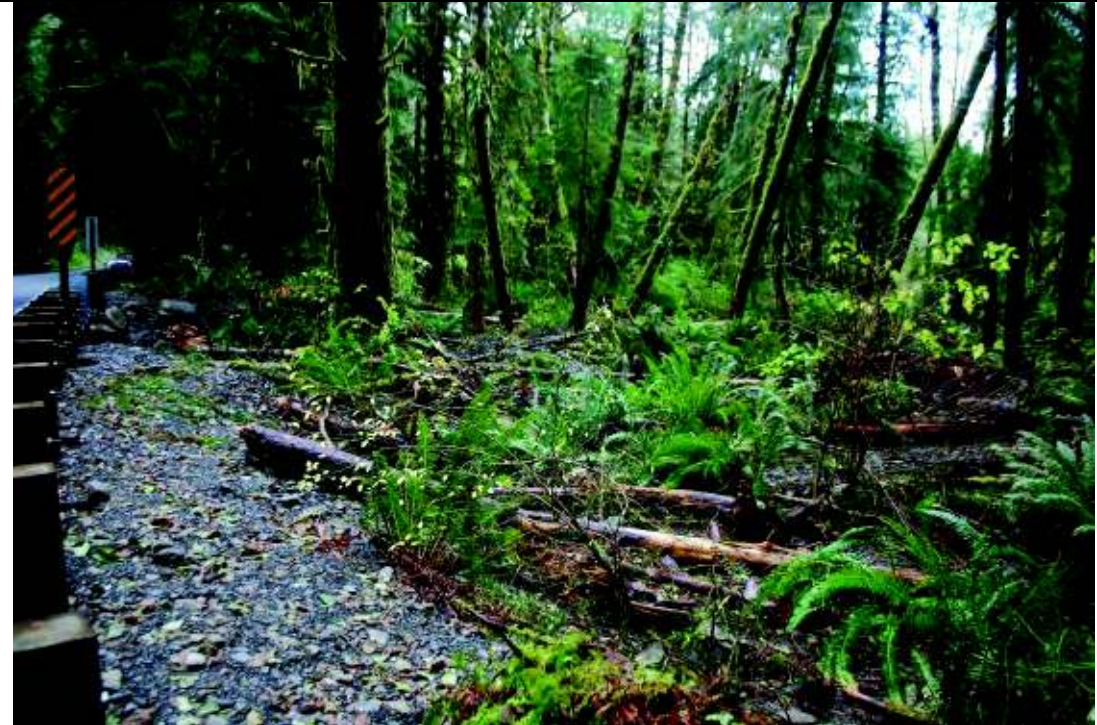
Post-construction conditions were observed during the site visit. Stream conditions appeared favorable for fish passage, including sufficient woody debris in the channel helping to create pools. Construction site impacts appeared very well restored: gravel imported for the bypass road had been removed; sufficient woody-debris had been strategically scattered on the bypass road site and other construction impacted areas to restore habitat values and limit erosion potential; and a natural distribution of mature native plants were transplanted to the site, making it difficult to even determine where the bypass road was located and where other construction impact areas were.

**Photo 1. Site of Upper Hoh Road bypass used during bridge construction and decommissioned and naturalized with woody-debris and relocated live mature plants post-construction.**

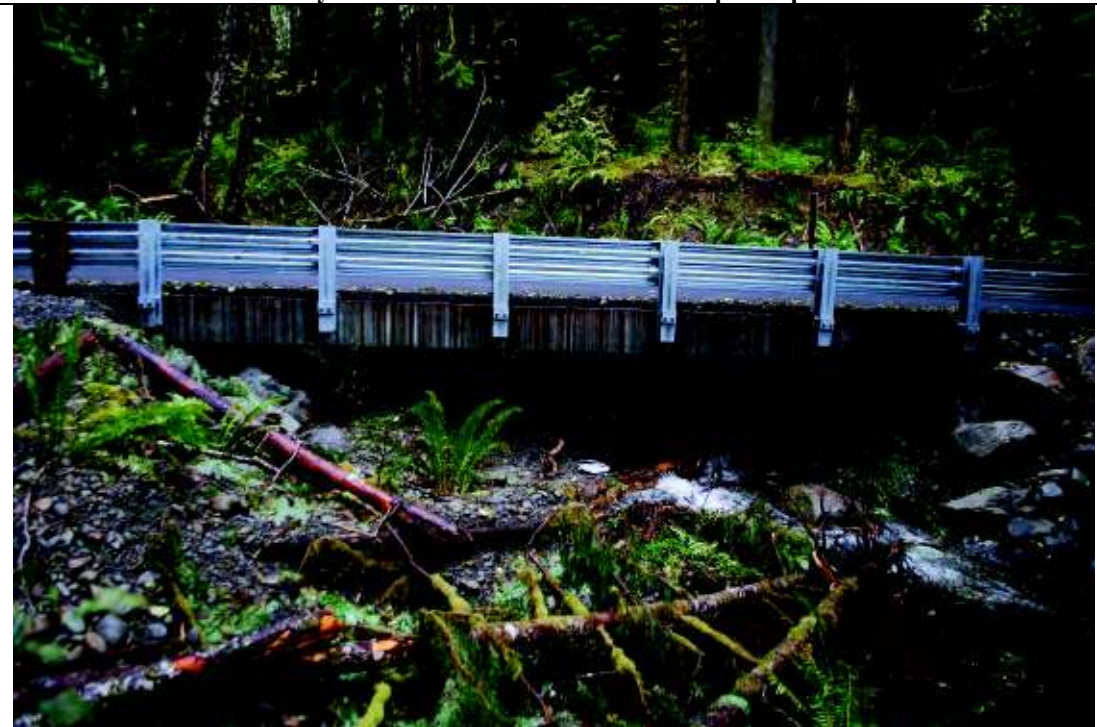
**Photo 2. New Upper Hoh Road cement bridge over Pole Creek, in HRT's Spruce Creek Unit.**

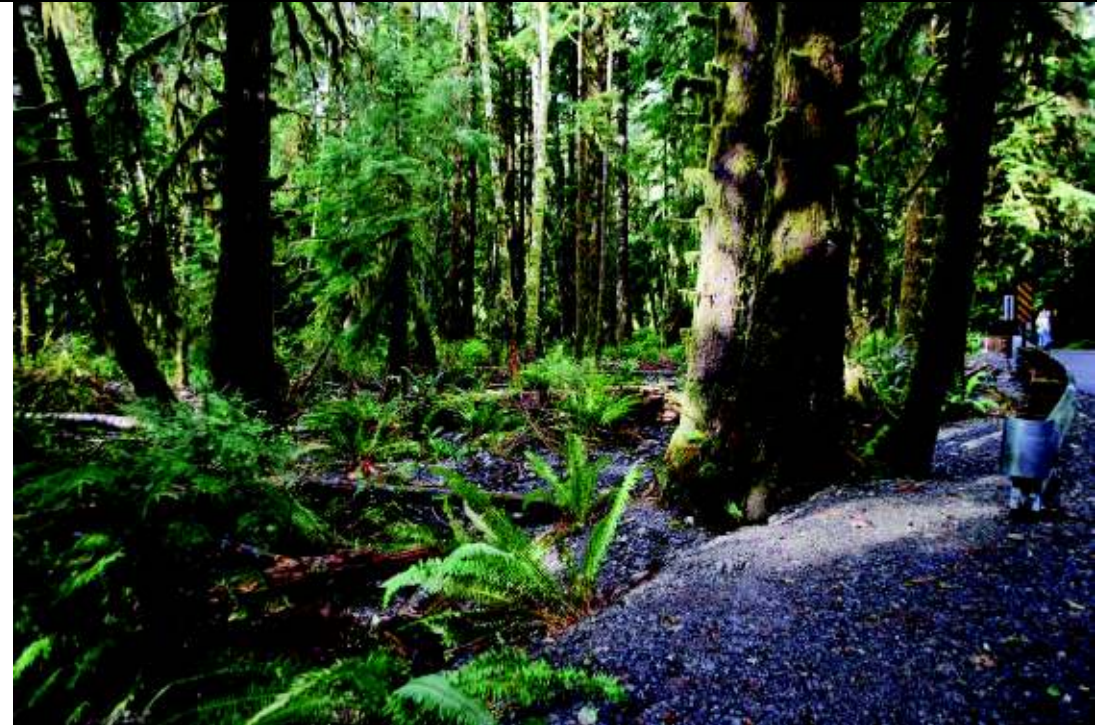
**Photo 3. Site of Upper Hoh Road bypass used during bridge construction and decommissioned and naturalized with woody-debris and relocated live mature plants post-construction.**

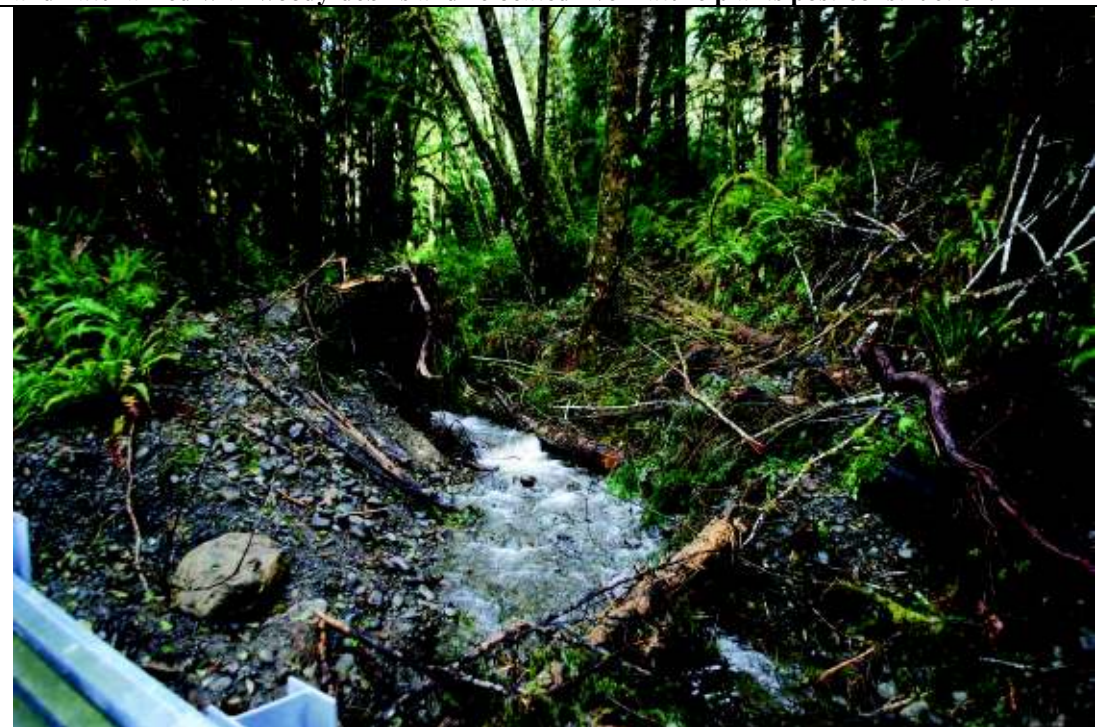
**Photo 4. Pole Creek conditions upstream of new bridge, including woody-debris in stream, and naturalized construction area**

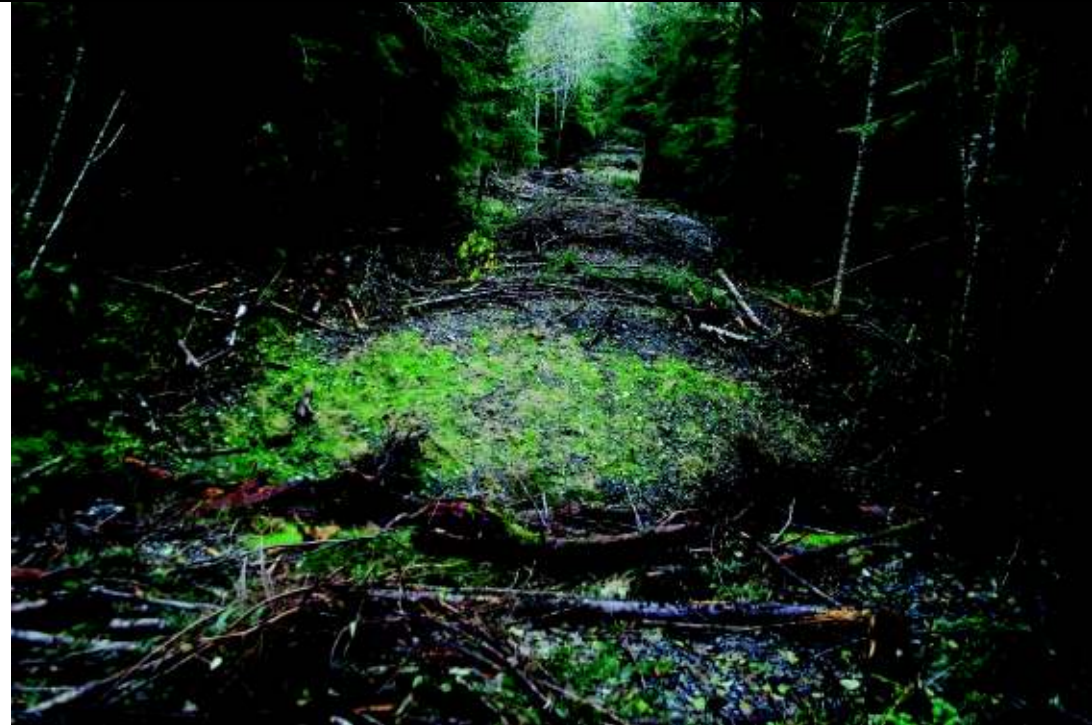
The old roads were observed to be decommissioned using woody-debris to cover the road-bed, increasing the nutrients and conditions needed for natural plant propagation and manual planting. At culvert removal sites, the road fill had been excavated above and around the stream channel. The original stream gradient appeared to be restored and the removed road fill was placed on the nearby decommissioned roadbed, while exposed stream banks were hayed and grass seeded. Woody-debris was placed in the stream

**Photo 5. Decommissioned upper Pole Creek Basin road, including woody-debris placement.**

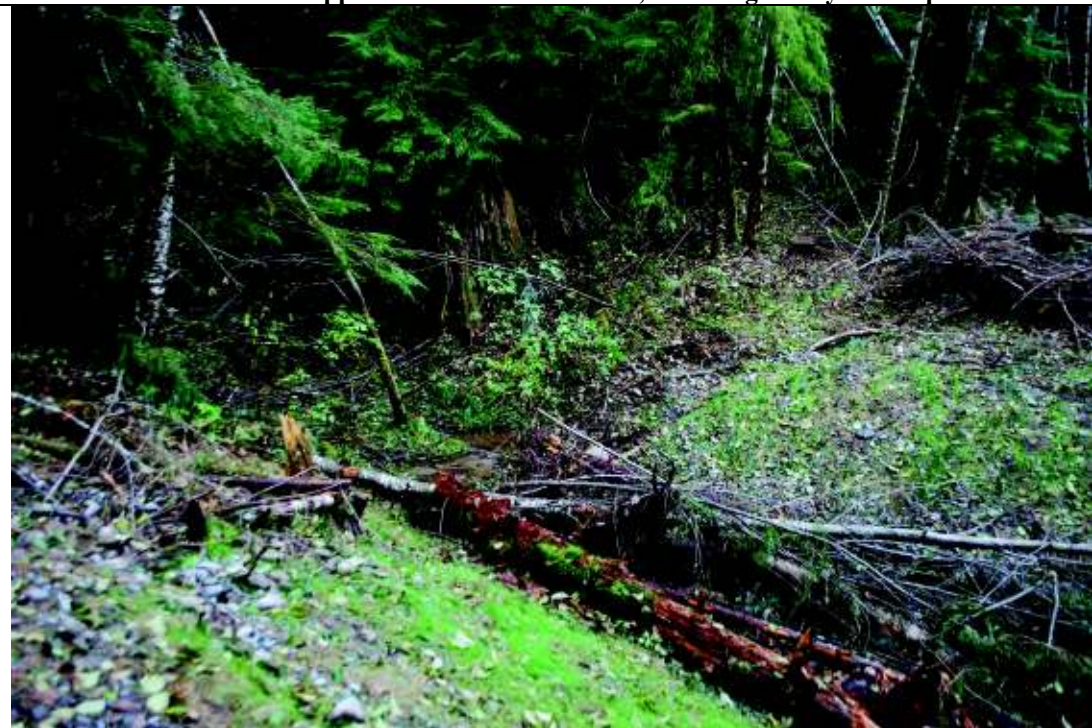
**Photo 6. Representative culvert removal and road decommission site at tributary to Pole Creek, in Upper Pole Creek Basin.**

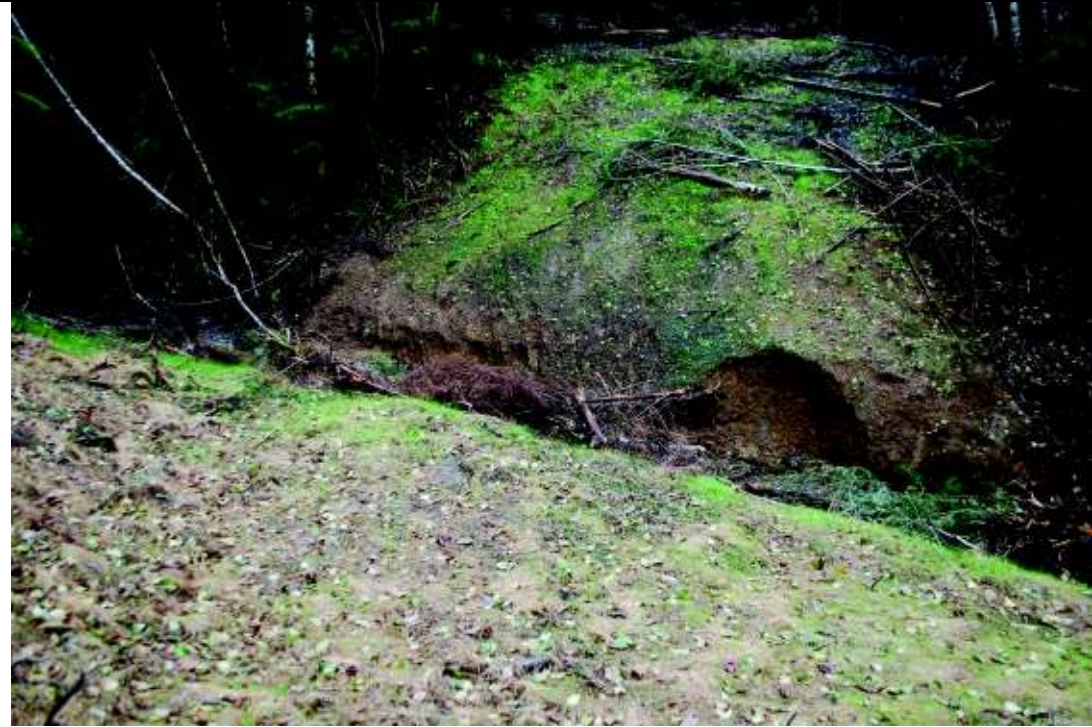
**Photo 7. Representative culvert removal and road decommission site at tributary to Pole Creek, in Upper Pole Creek Basin.**

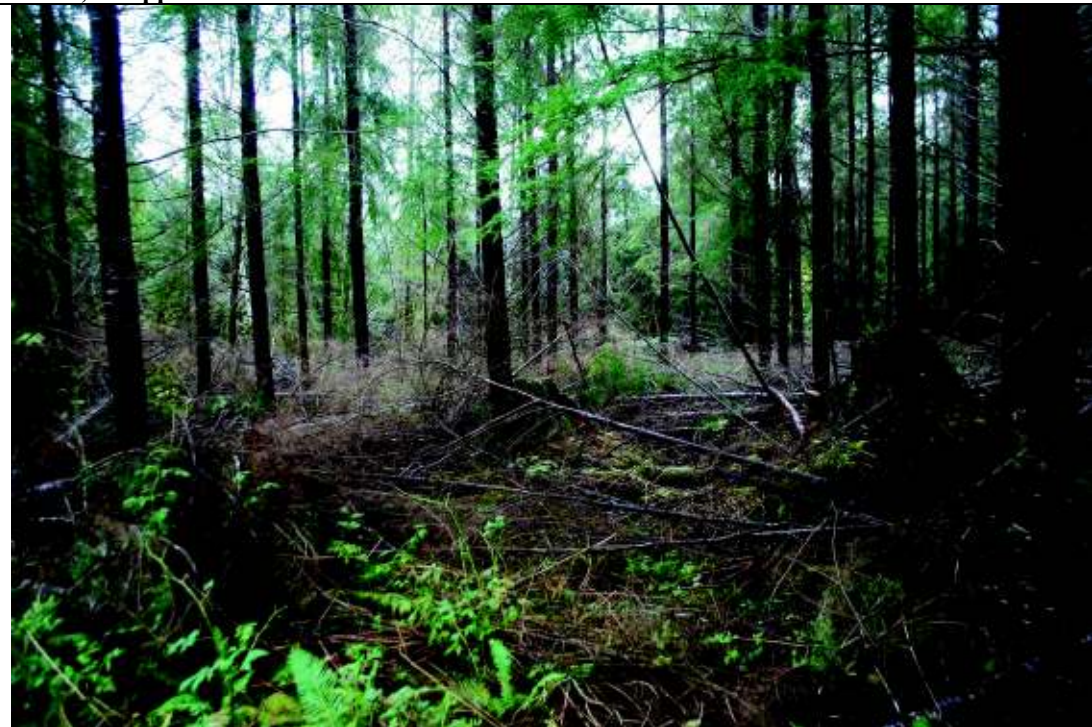
Approximately 135 acres of the northwest portion of the Spruce Creek Unit were thinned this spring. The project was focused on removing spruce-tip weevil infested trees, while saving hardwoods and other non-planted native trees, particularly western red cedar, to increase the diversity of the stand. Evidence of the thinning project was observed from Spruce – 1100 road. As a spruce plantation, the primary remaining tree species continued to be Sitka spruce in an even spacing. Several young cedar trees were observed among the site, as well as alder, western hemlock, and willow species which appeared to be deliberately retained as part of the thinning project. Small openings could also be observed from the road, intended to improve structural diversity of the forest and wildlife habitat conditions.

**Photo 8. Pre-commercial thinning site in Upper Pole Creek Basin forest**

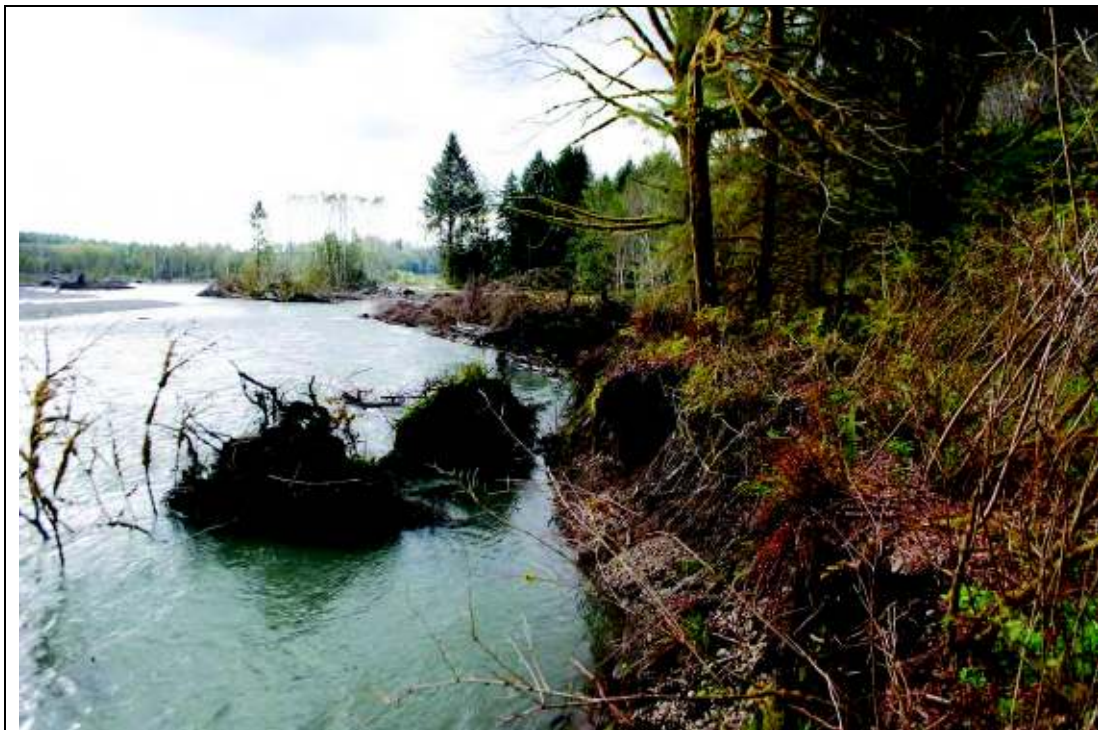
The old homestead site and surrounding forest has undergone dramatic change in the past year due to a major shift in the river channel. The river channel moved at least 1,500 feet, removing approximately 15 acres of riparian forest from the northern section of the Schmidt Bar Unit near the old homestead. The remaining old homestead area has also been managed for the removal of invasive blackberry plants using a small excavator, and for the removal of Canada thistle using a bio-control. Direct results from the removal project were observed, with large populations observed during previous monitoring visits no longer present. New plants were observed sprouting from seed and root fragments in and around the management areas. Due to the perennial nature of the Canada thistle, the results of the bio-control management were not observed, and will be assessed in the coming growing season.

**Photo 9. Extensive new natural erosion of Schmidt Bar unit by meandering river channel.**

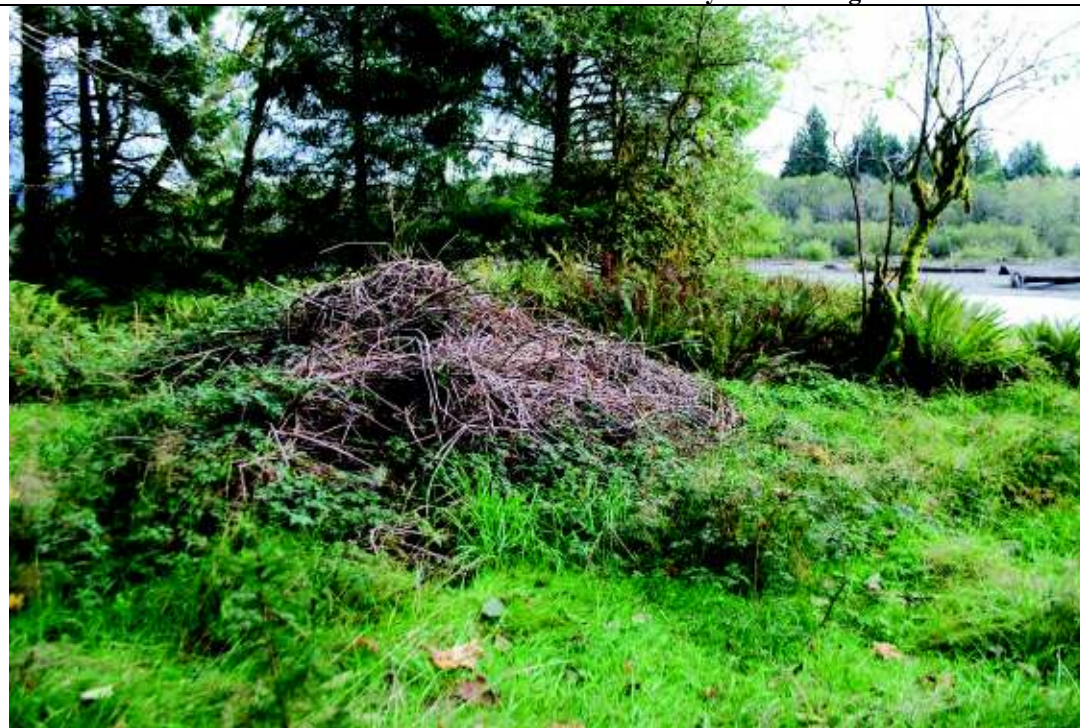
**Photo 10. Invasive blackberry removal site representative conditions.**
